Final report RL 2012:21e

**Serious incident on 16 of January 2010 to
aircraft EP-IBB at Stockholm/Arlanda
Airport, Stockholm county, Sweden**

Ref.no. L-02/10

2012-12-28

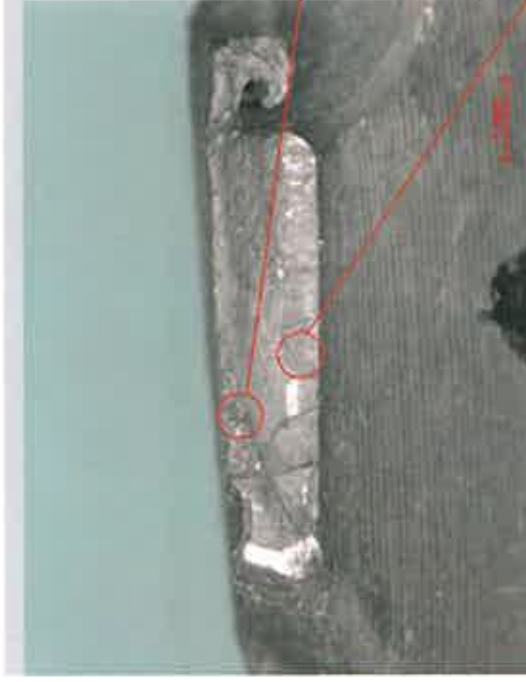
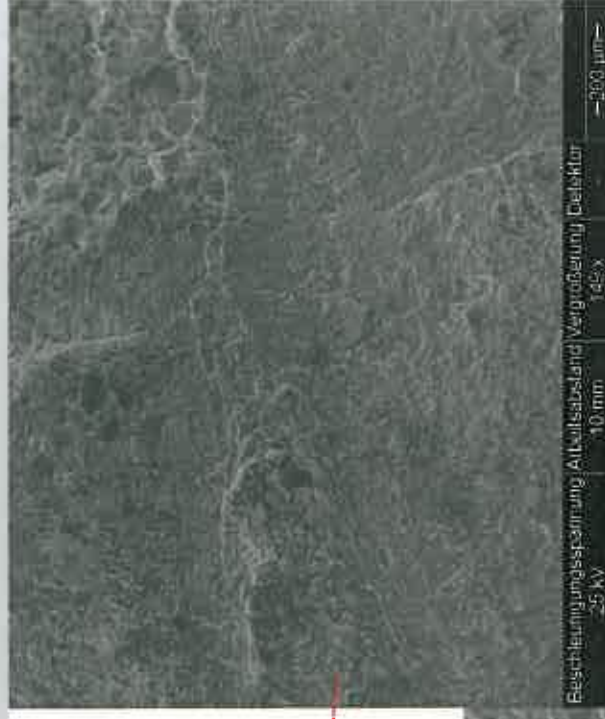
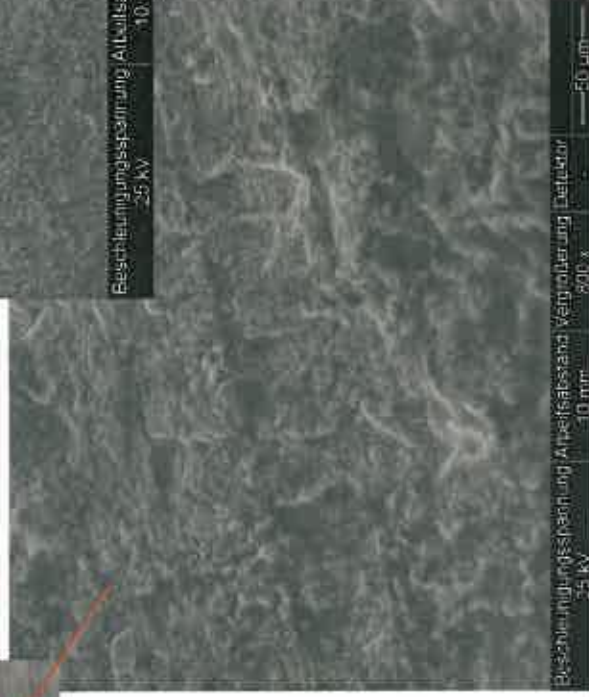
HPT Diffuser Aft Seal

Fractured lug with fatigue fracture indications

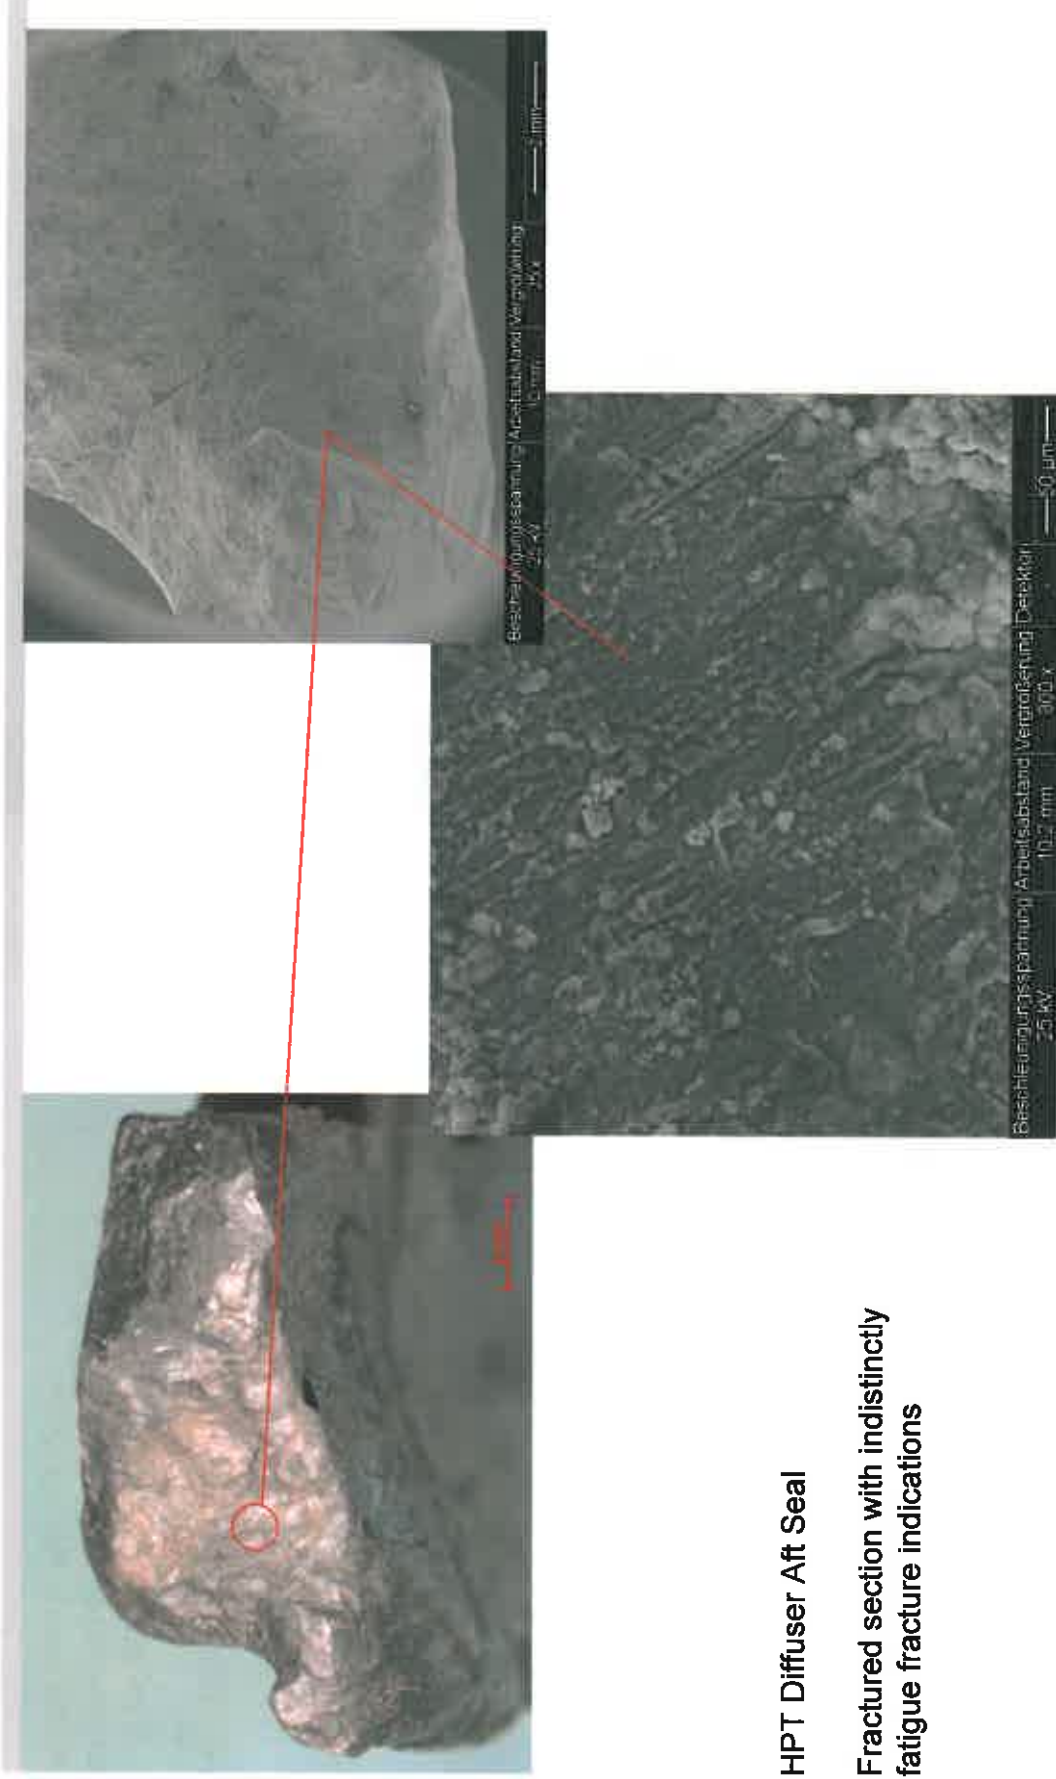
HPT Diffuser Aft Seal

Fractured section with indistinctly
fatigue fracture indications

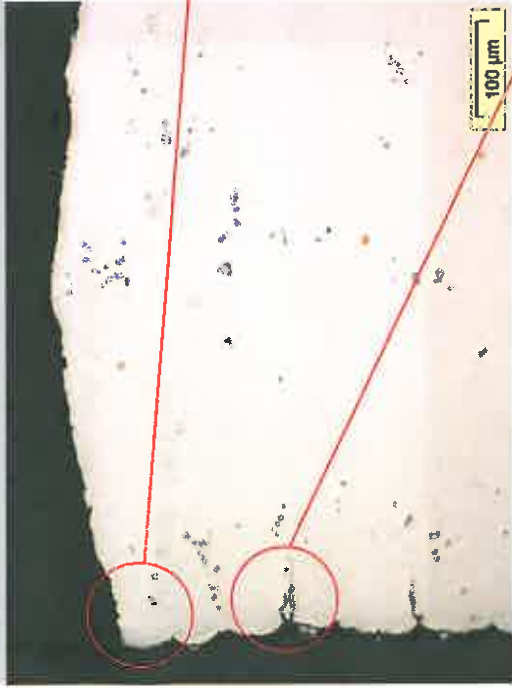
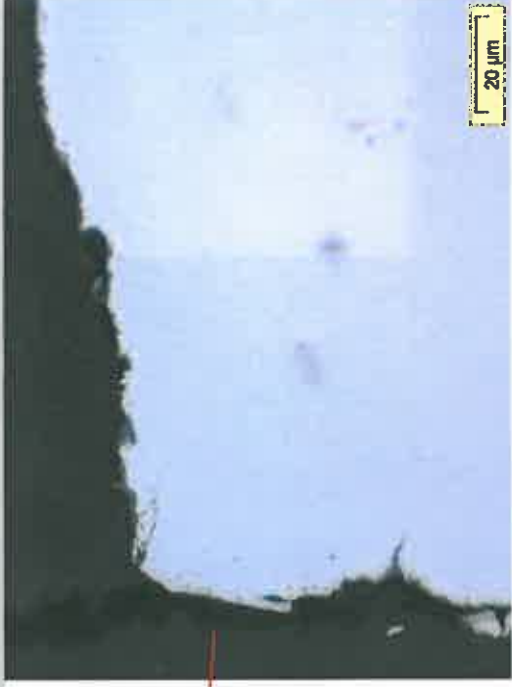
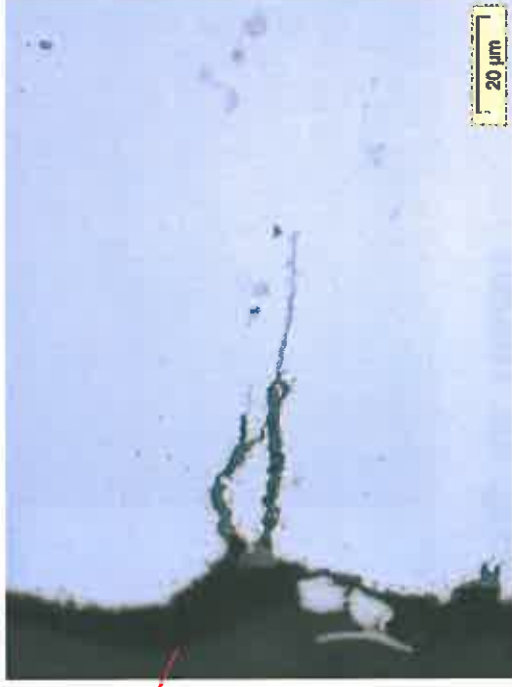
HPT Diffuser Aft Seal

Lug fracture origin exhibiting thermal fatigue and secondary thermal fatigue cracks next to fracture origin

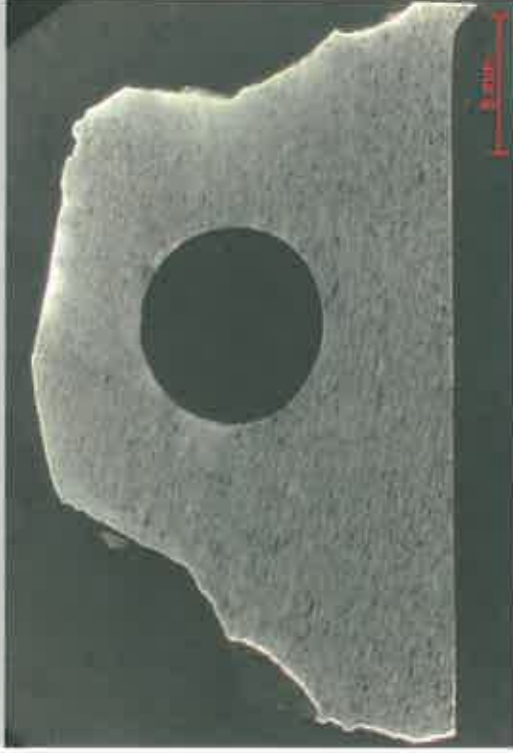
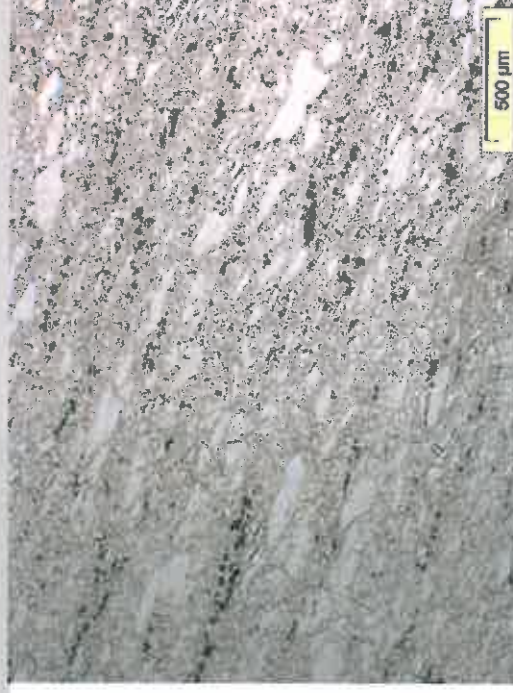
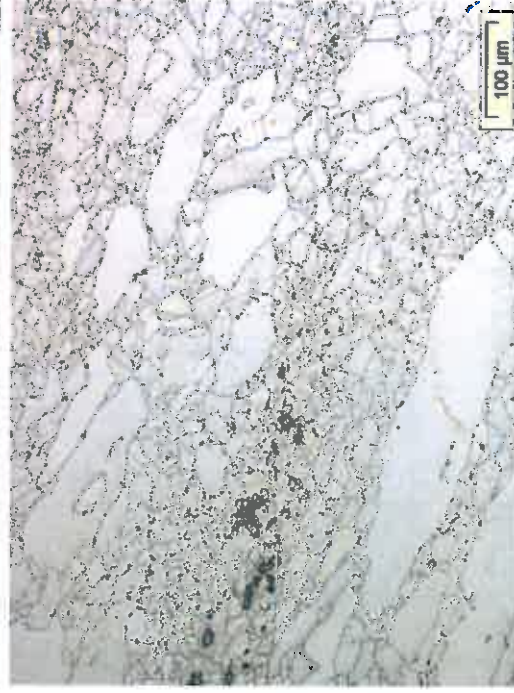
HPT Diffuser Aft Seal

Slightly ovalized seal lug (top left)
and general microstructure (right)

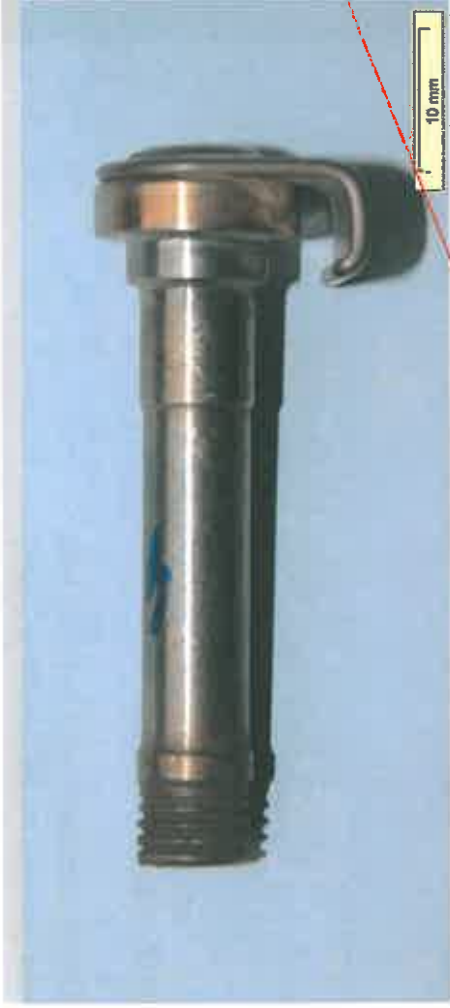
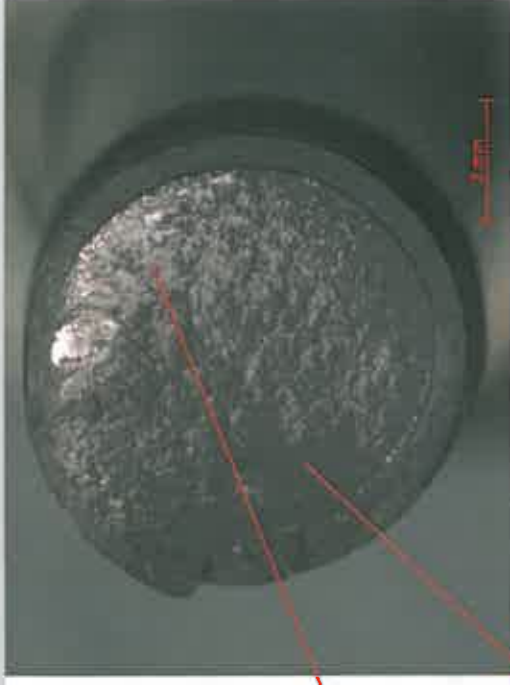
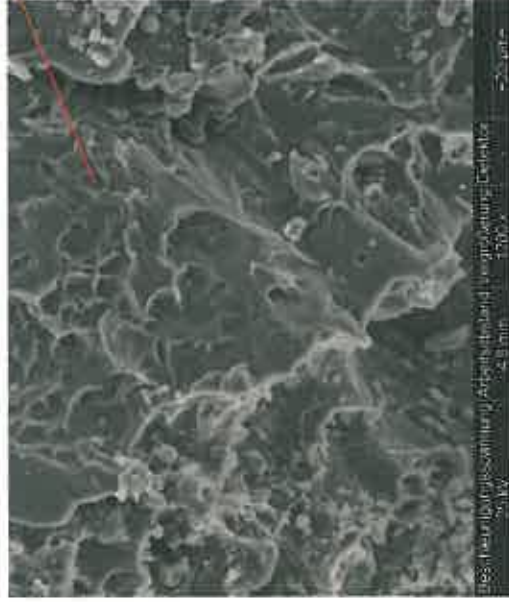
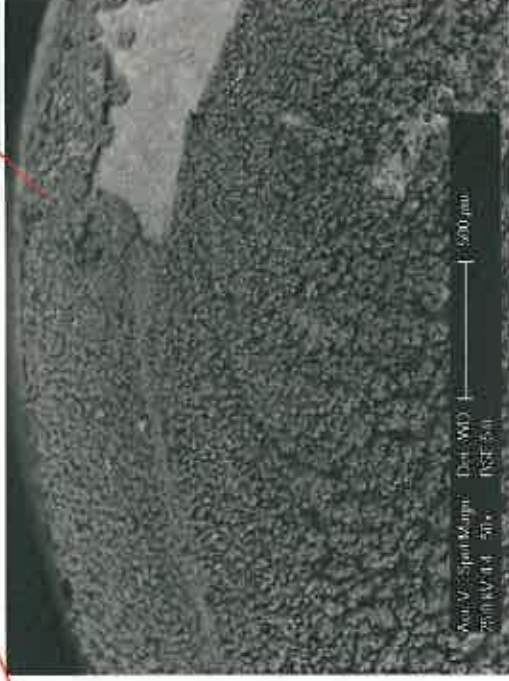
Hookbolt

Fractured hookbolt and fracture face (top) detailed SEM views of shear structure (bottom left) and foreign material overspray (bottom right)

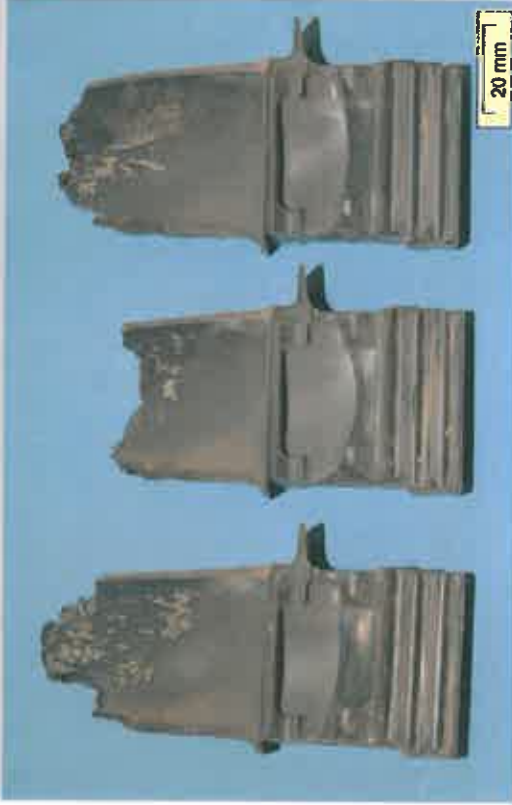
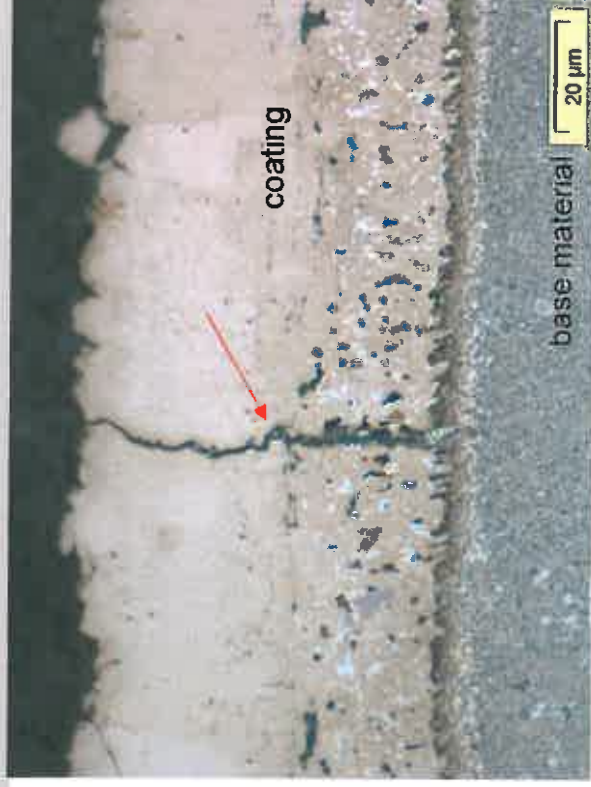
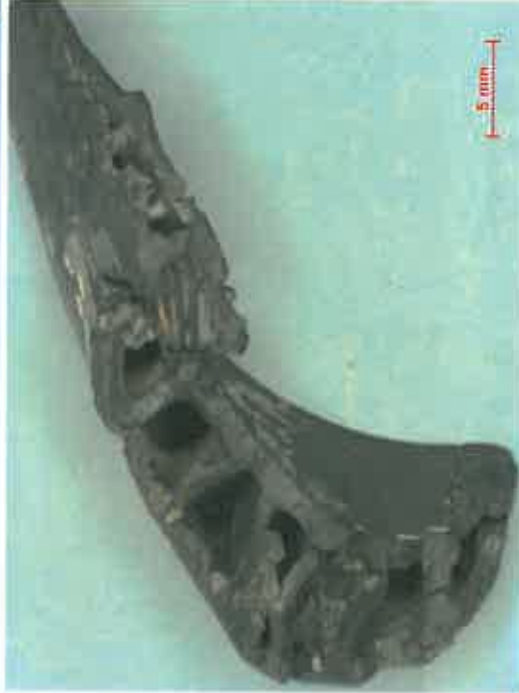
HPT Blade

Fractured blades (top left), fracture face of blade airfoil (bottom left) and oxidized / sulfidized crack through the airfoil coating (top right)

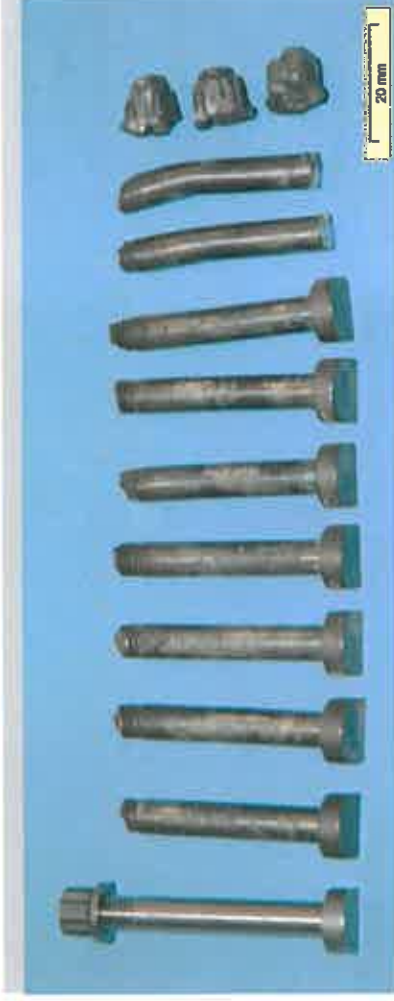
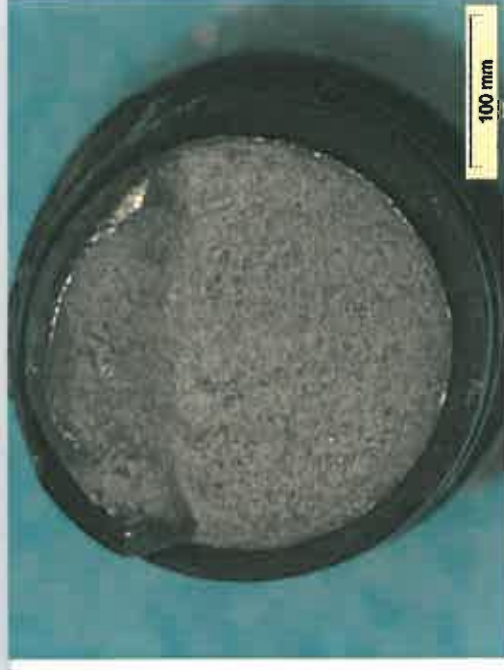
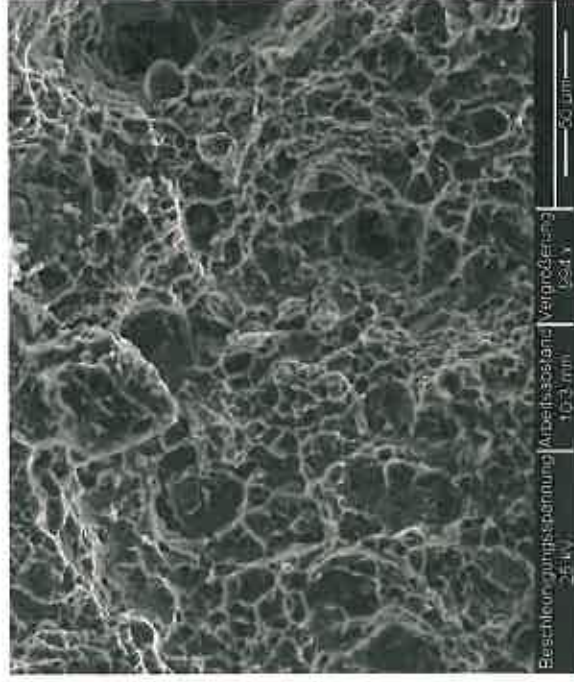
Ring Bolt

Fractured ring bolts (top), typical fracture face (top right) and SEM view depicting the ductile structure of the fracture (bottom left)

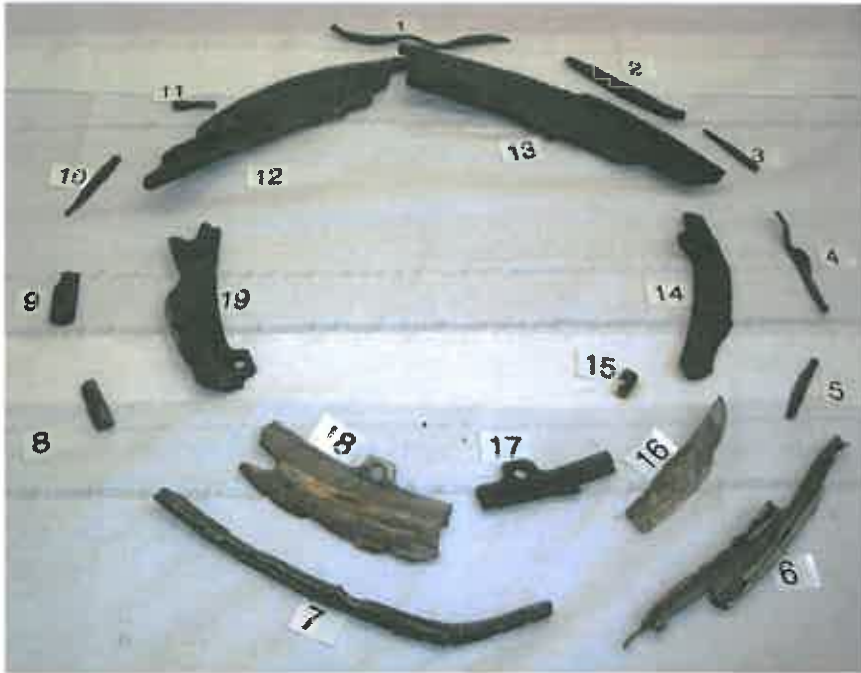
Photo No 2. LHT photo showing Diffuser Aft Seal fragments.

Some of the missing pieces were received as molded sections.
The fracture surfaces from the lug of fragment 13 are available as molded sections.
Pieces 4, 5, 9, 10 and 11, on photo no 2, are not believed to come from the Diffuser Aft Seal, based upon visual appearance and geometry.
Piece No 9 is confirmed by GE Aviation to be a HPT Stage 1 Nozzle air cover baffle.

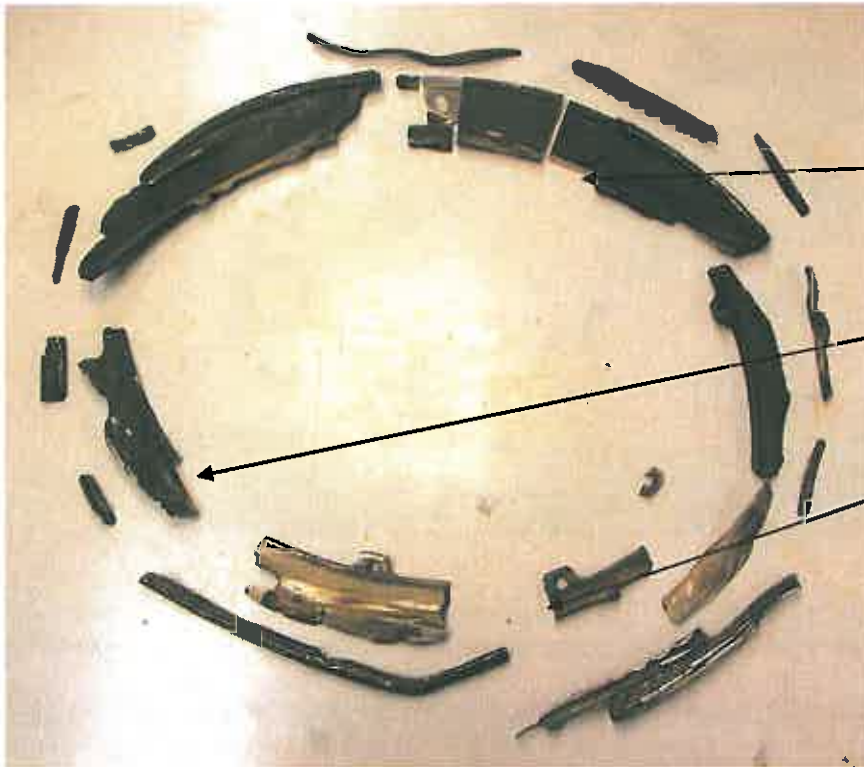
Photo No 3. All of the fragments were received. LHT have cut sections from No 13, 17 and 19.

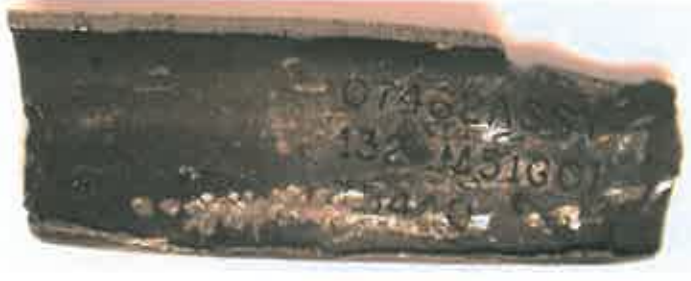
Photo No 4. Piece no 9, HPT Stage 1 Nozzle air cover baffle.

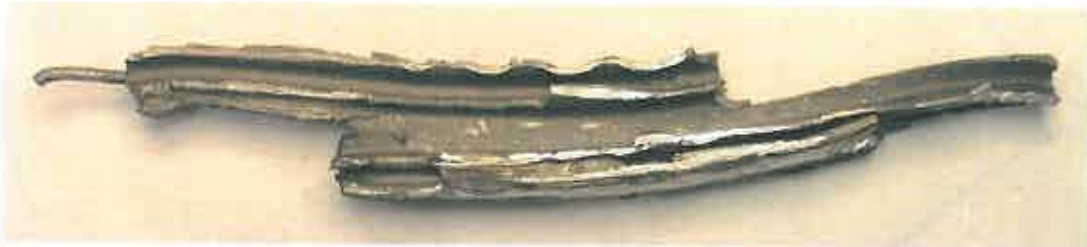
Photo No 5. Piece No 6 is the only fragment with the four seal teeth in the same piece.

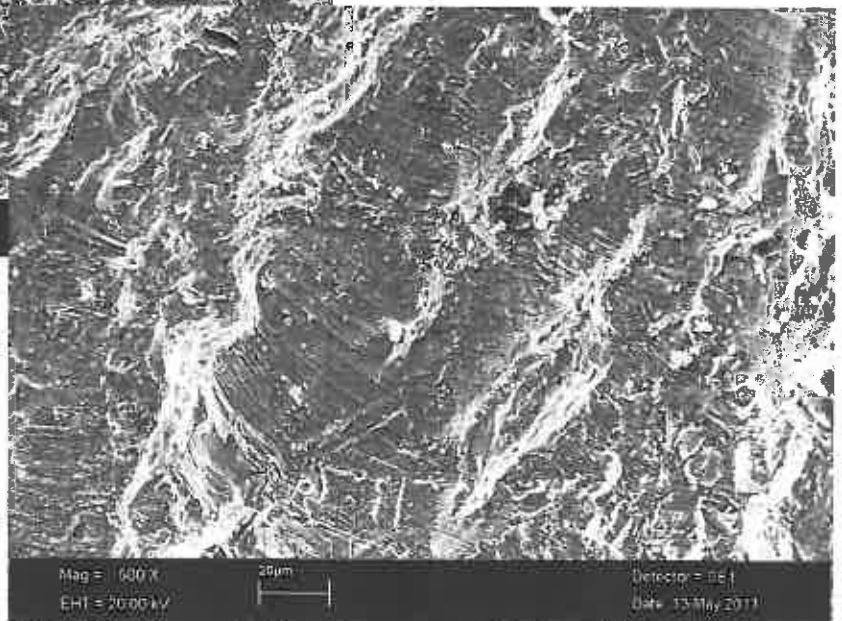
Photo No 11. Fatigue striations in a comparatively oxide free surface.

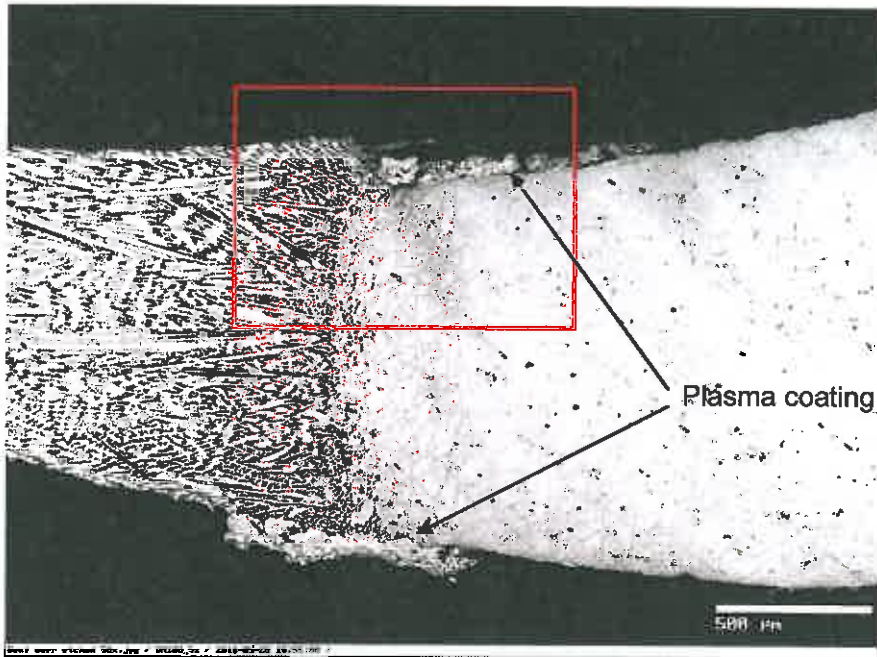
Photo No 14. Higher magnification of the dabber weld interface.

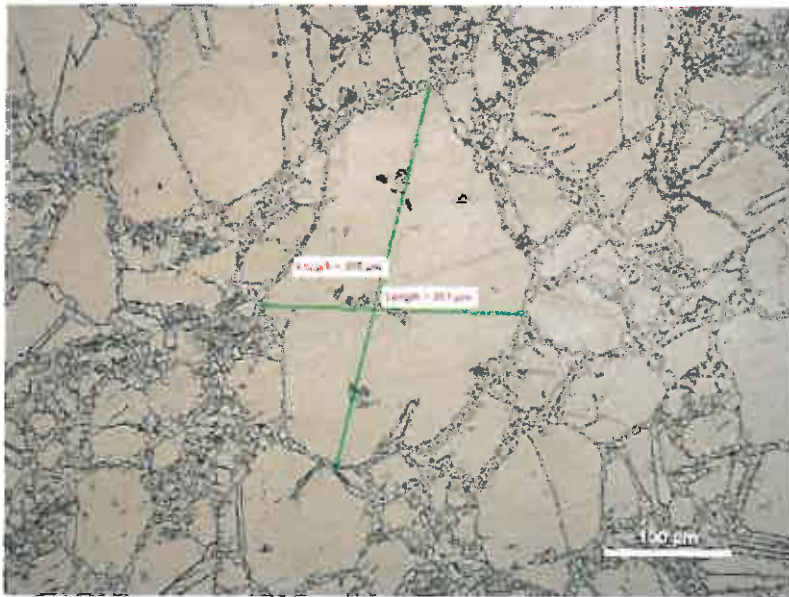
Photo No 18. The grain size of the seal tooth base material, about 3 mm from the weld interface, was evaluated per GE C50TF37 CL B per ASTM E 112.

Duplex, necklace structure is not permitted according to the requirements.
The largest grain in photo No 18 is 0.30 x 0.20 mm which is not permitted.
